# Case Study

STUART  
DEAN

Student  
Recreation Center

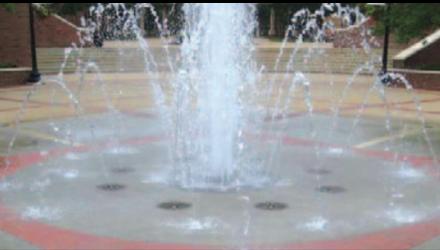
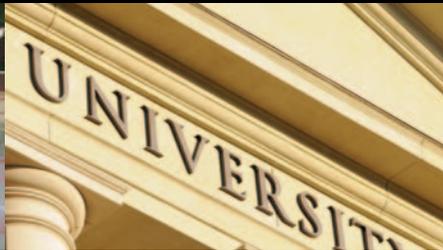
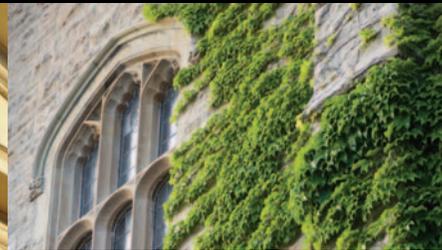
*Staining from food service and refuse containers on the center plaza was having a negative impact on the overall appearance of the poured concrete and concrete pavers.*

*Discarded chewing gum on the poured concrete surfaces and concrete pavers also contributed to the degraded conditions.*

*Intermixed materials throughout the project area created a pattern of adjacent protected and unprotected concrete. The surface materials consisted of unprotected concrete (no sealer or coating) along with painted concrete and an area of concrete with an unknown sealer. Also, the plaza's water fountain feature and painted concrete accent details required special attention.*

Stuart Dean started with an overall evaluation of the current conditions, testing absorption rates of the surfaces and completing sample areas. After this analysis, Stuart Dean performed the following cleaning methods:

Once the areas were cleaned properly and allowed to dry, the application of APP Surface Guard was completed by airless sprayer with fine tips (.052) in a two-layer cross hatch.

The restoration and protection processes immediately resulted in a much improved, cleaner surface appearance. The application of APP Surface Guard will ensure that the surfaces will be more resistant to staining.
